**Update on the Clean-up Following the Accident  
at a Fuel Storage of Norilsk Nickel**

June 22, 2020

# Accident Overview

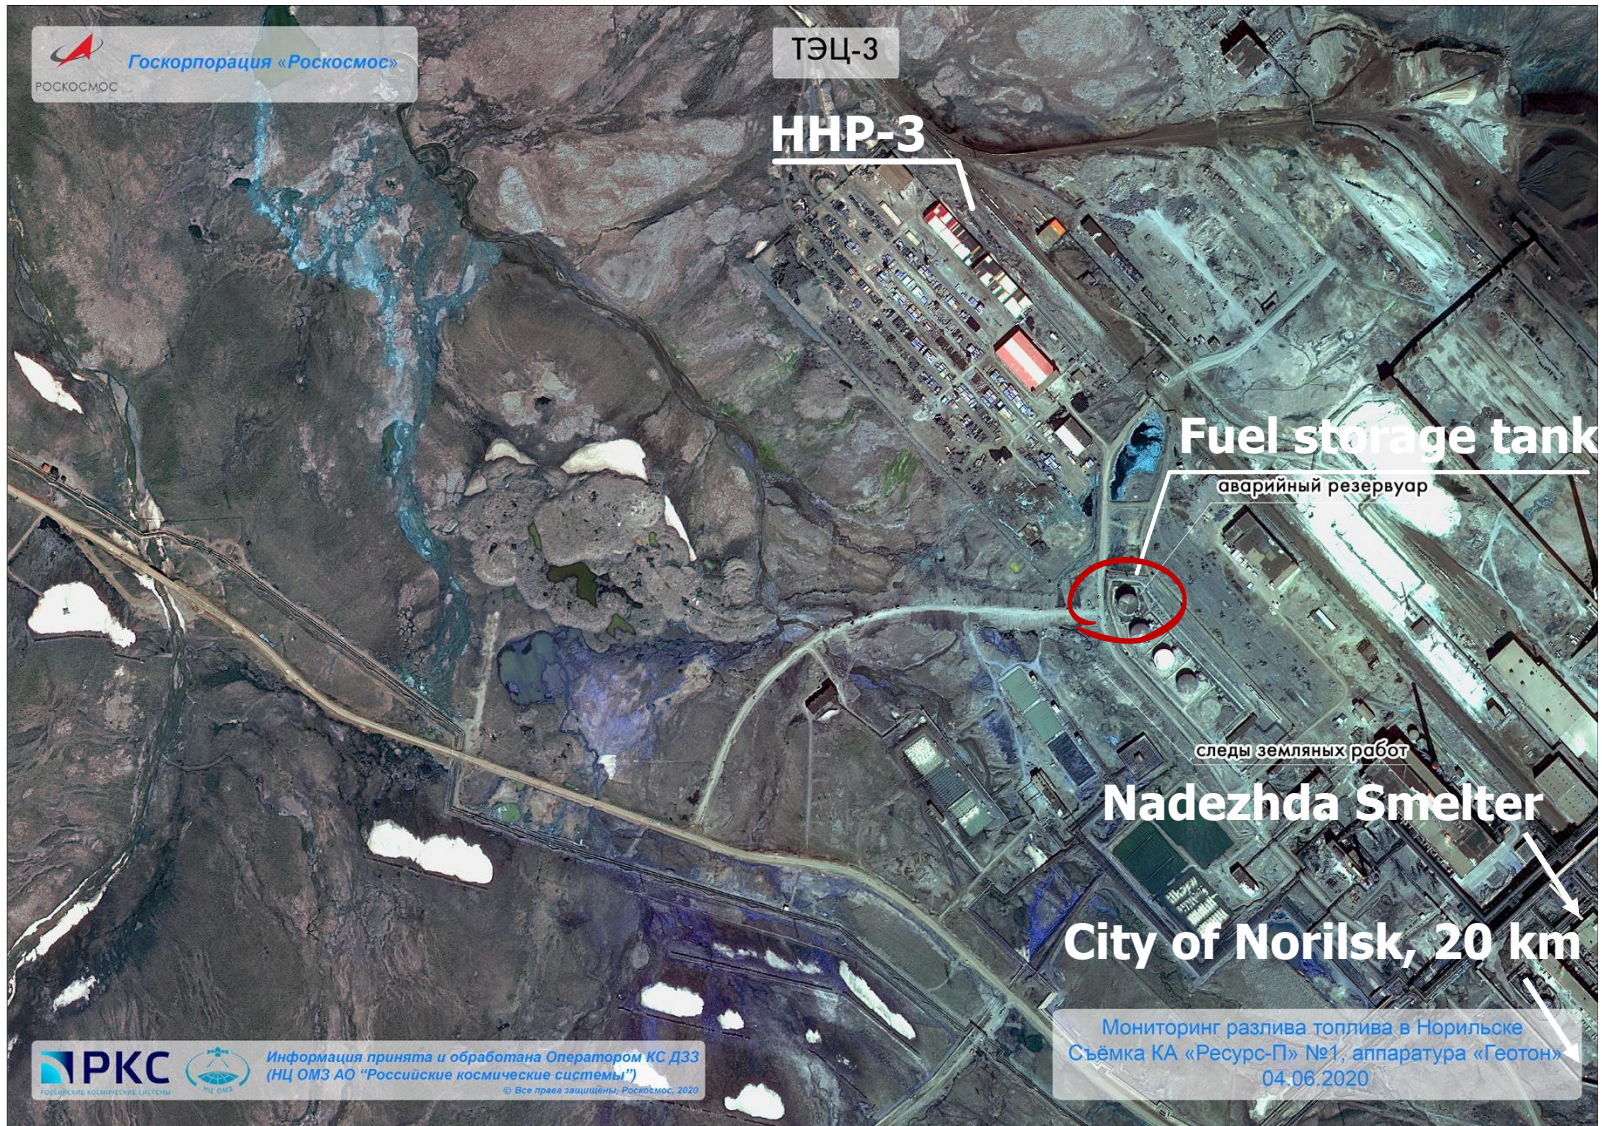
# ROSKOSMOS Satellite Images of HHP-3 and Damaged Fuel Tank

- On May 29, 2020, an accident occurred whereby the containment of the emergency fuel storage at Heat and Power Plant № 3 (HPP-3) in the Kayerkan neighborhood of Norilsk failed due to sudden sinking of support posts, resulting in the fuel leakage

- According to the Company's assessment, the accident could have been caused by the thawing of permafrost which resulted in sinking of support posts
- Since the HPP-3 is located remotely from Norilsk, the city has not been impacted

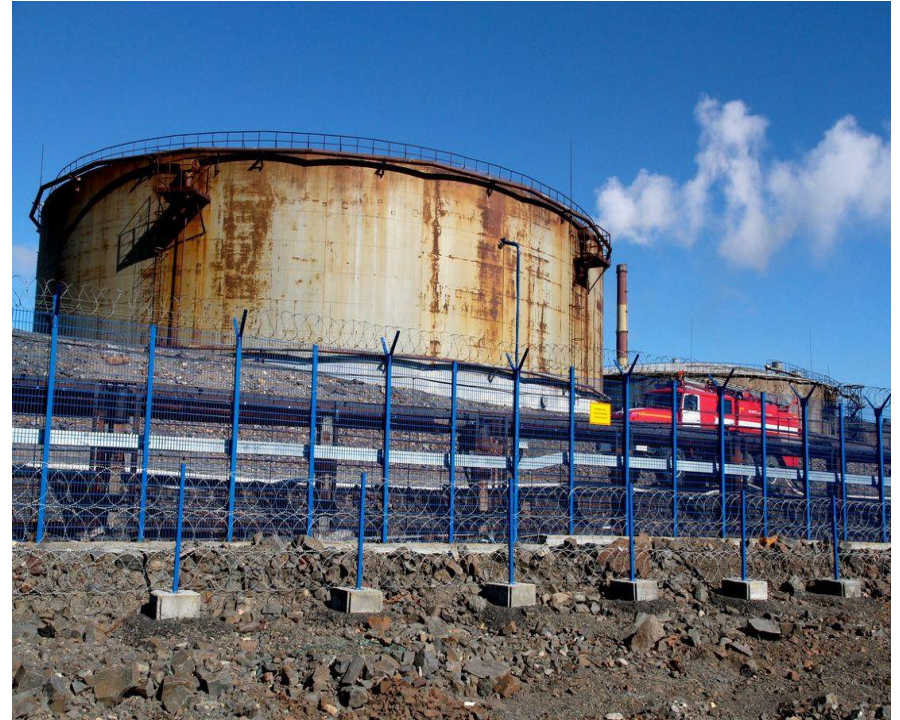
- HPP-3 is operated by Norilsk Nickel's wholly-owned subsidiary, Norilsk Taymir Energy Company (NTEC)
- The HPP-3 predominantly serves the local municipality of the Norilsk Industrial District and supplies some power to Norilsk Nickel's facilities
- HPP-3 consumes natural gas, with diesel fuel used only in emergencies and stored in fuel reservoirs
- The reservoir #5, where the accident took place, was built in 1985
- After undergoing repairs in 2017-2018, the reservoir #5 went through hydraulic testing and Industrial Safety Audit (ISA) in 2018
- All recommendations of ISA regarding filling the reservoir #5 for the first time after the repairs were followed and controlled

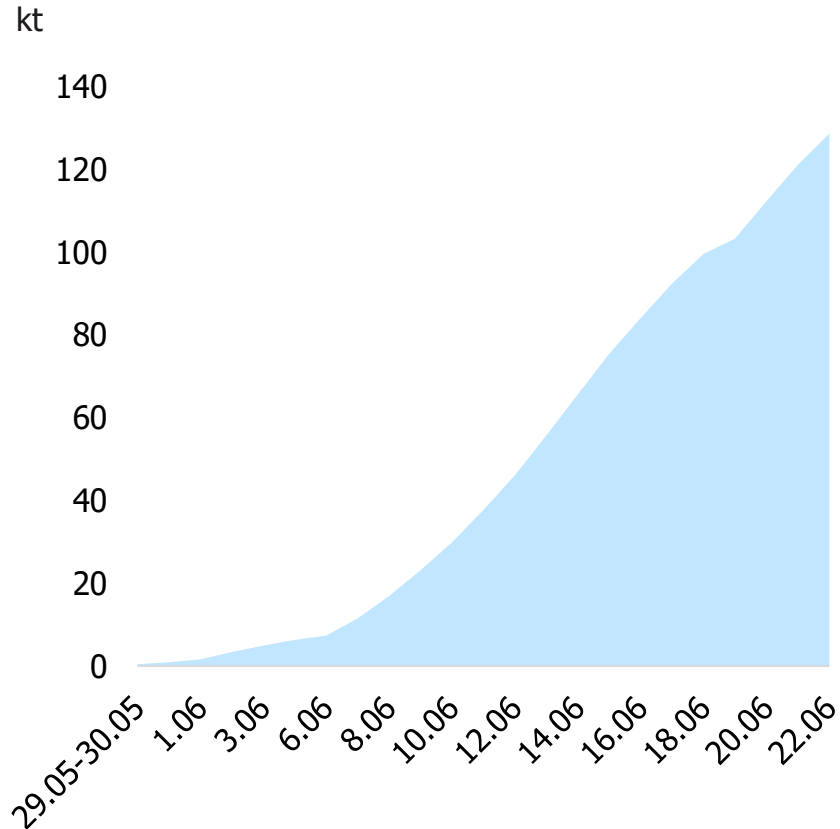
Contaminated Soil Removed:  
Cumulative Volume

- ✓ 103kt of contaminated soil has been removed near HHP-3
  - ✓ 32k cubic meters of water-fuel mixture has been collected near HHP-3 and from the Ambarnaya river

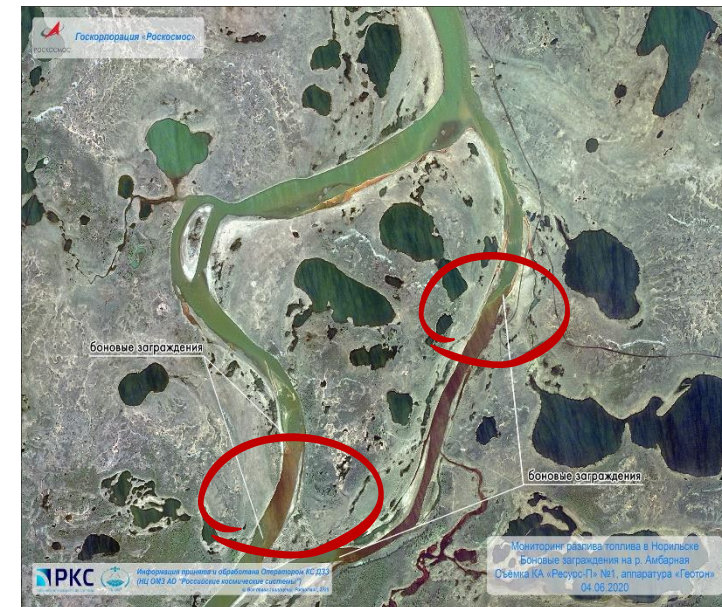
- **Special containment boms (in total 55 lines) have been installed in the Ambarnaya River, which have** prevented the spill from spreading to the downstream Pyasino Lake
- The spill has not reached Pyasino Lake
- There is no risk of pollution of the Kara Sea
- Regular aerial monitoring of the impacted area is carried out

- **Satellite images published by Roskosmos on June 4<sup>th</sup> confirm that the oil spill were well contained in the Ambarnaya river**

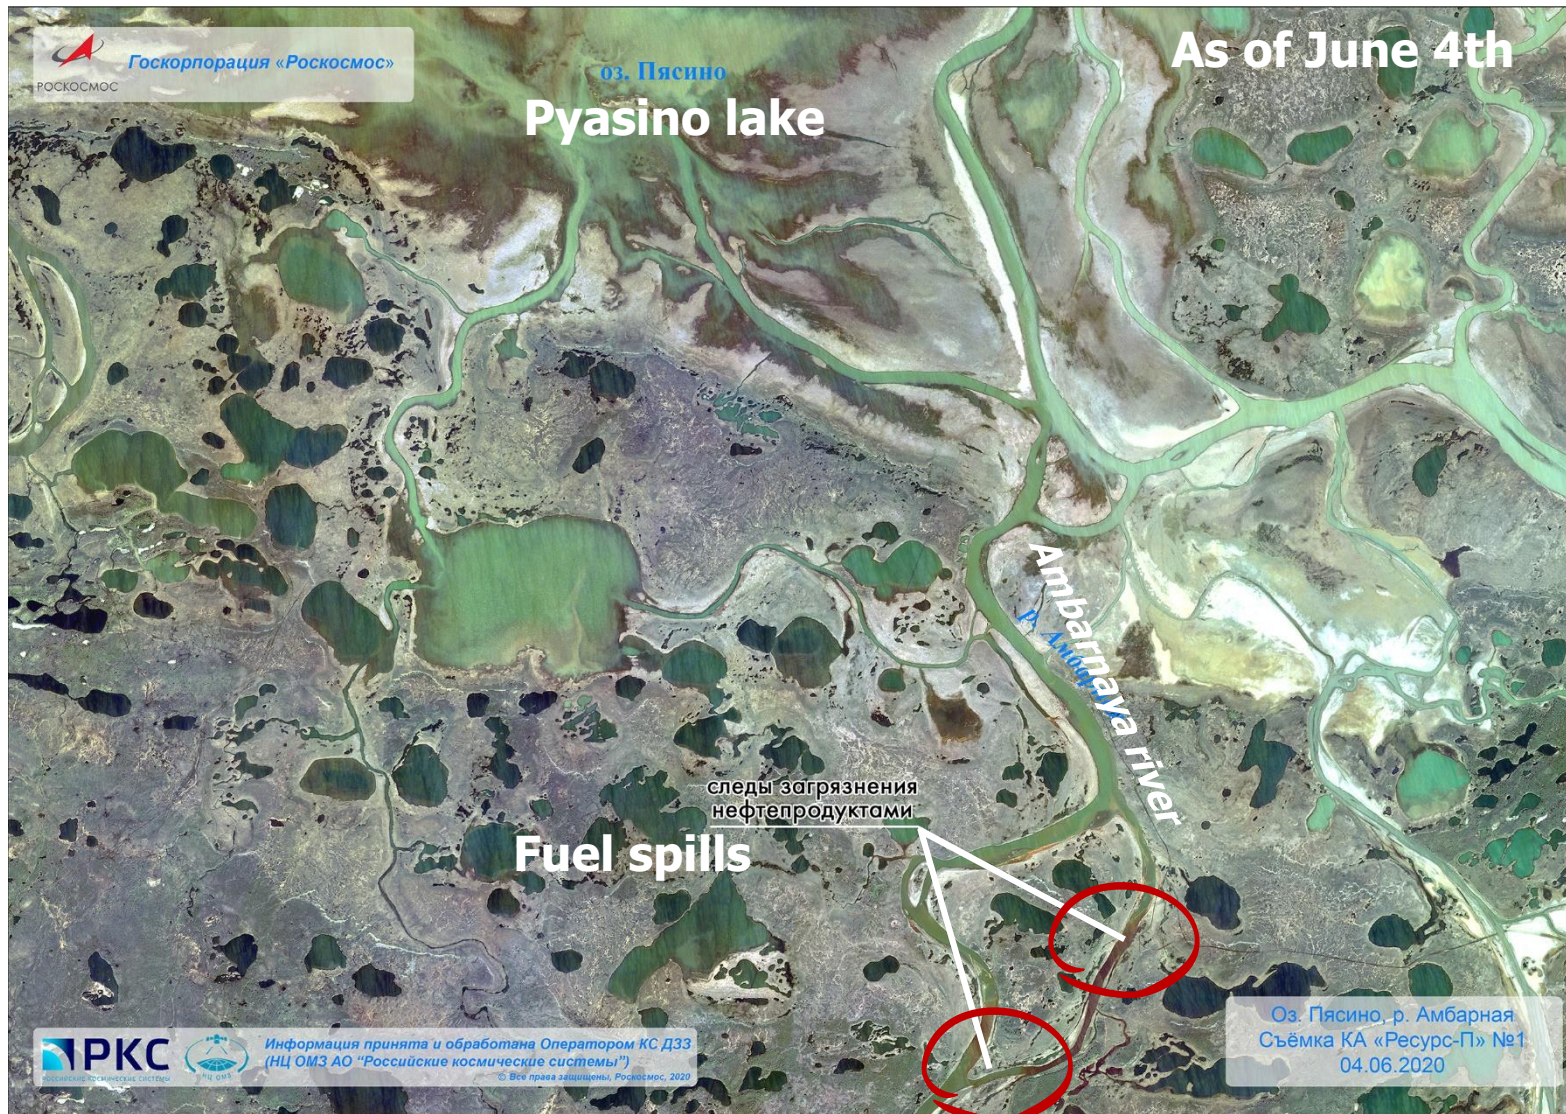
# ROSKOSMOS Satellite Images of Norilsk-Pyasinsky Water System

- The fuel spill through Bezymianny stream via Daldykan river reached Ambarnya river, where boms prevented the contamination of Pyasino lake
- The exact distribution of the contamination will be assessed through the soil recultivation, pumping out of the fuel from the pit and drain sumps, and cleaning of water

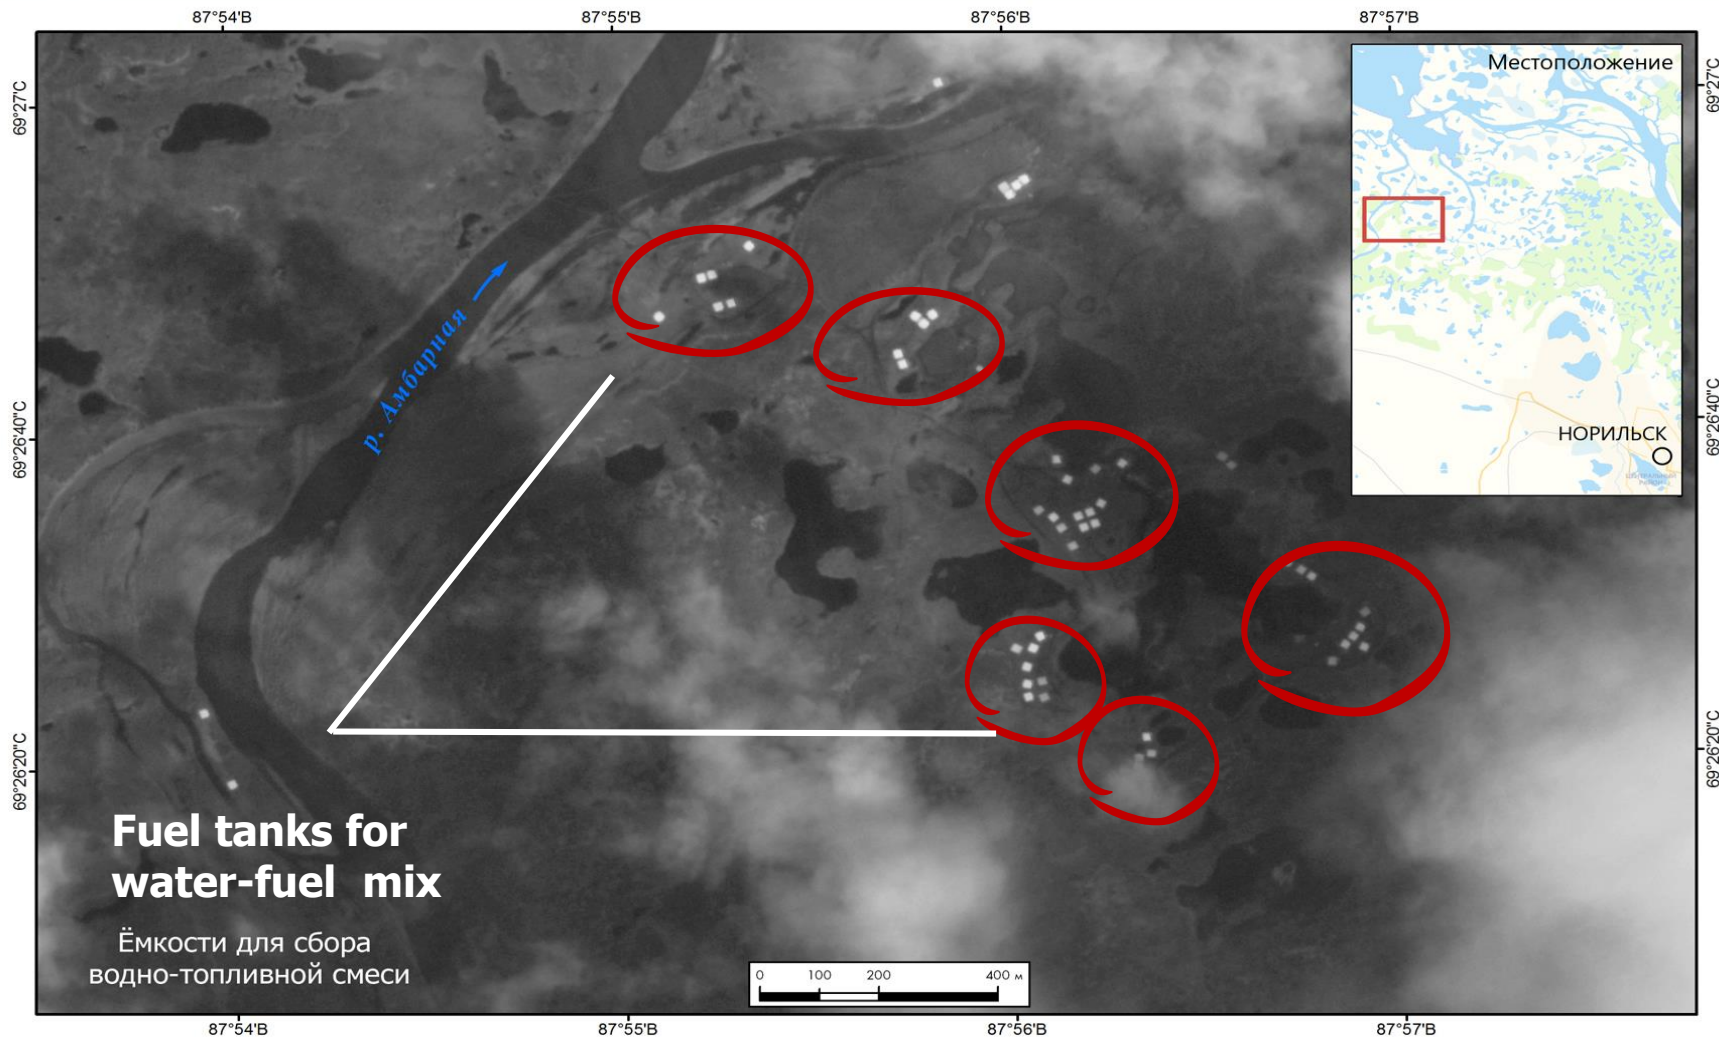
# ROSKOSMOS Monitoring of the Cleanup Progress as of June 15<sup>th</sup>

МОНИТОРИНГ ЛИКВИДАЦИИ ПОСЛЕДСТВИЙ РАЗЛИВА ТОПЛИВА. РОССИЯ, КРАСНОЯРСКИЙ КРАЙ, ДОЛГАНО-НЕНЕЦКИЙ АО  
ПО ДАННЫМ КА "КАНОПУС-В" №4 / ПСС 15.06.2020
